## Tragedy at Skyline—September 17, 1967: One Who Was There Investigates

# Tragedy at Skyline— September 17, 1967

*One who was there investigates*

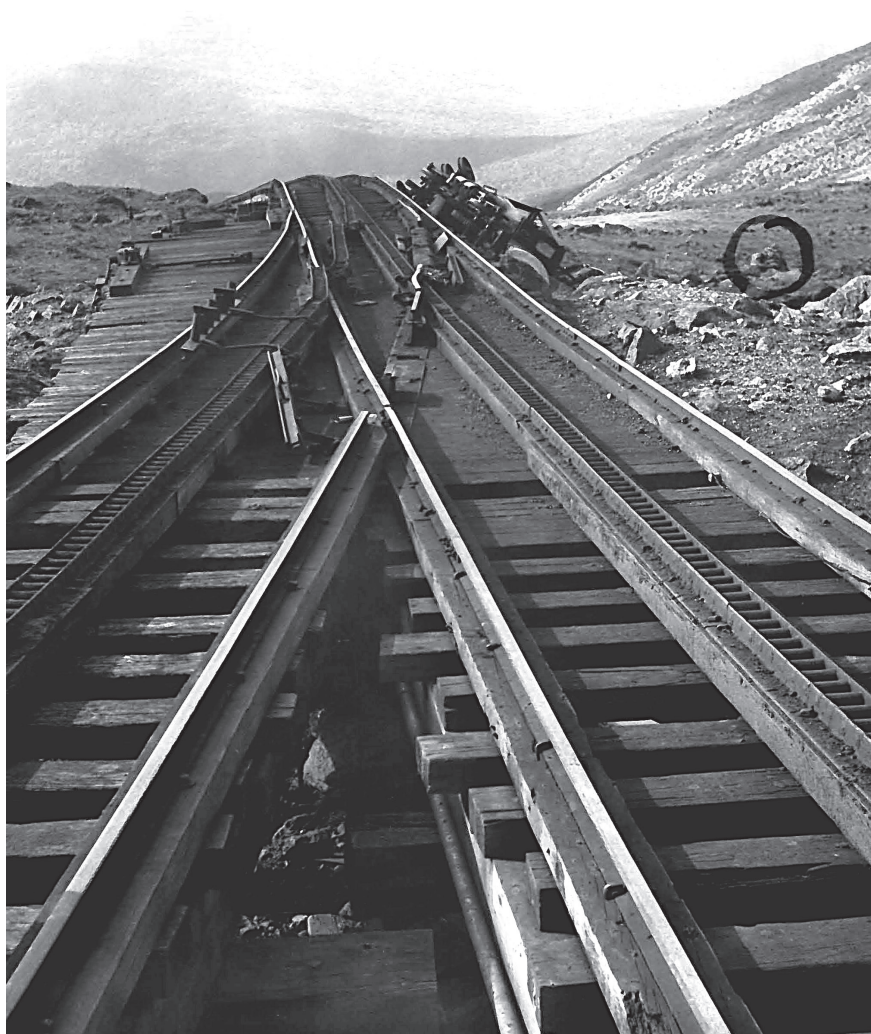
*The Cog Railway's engine lies overturned after hitting a misplaced mechanism on the sidetrack. Out of sight, the passenger car lies crashed. The accident killed 8 people and hurt 70. It's unknown why the police circled the rocks on the right side of the photo.*

What did the train hit? Accident investigators found a section of flip rail—a short, steel, hinged rail that supported cars as they moved on or off the track at Skyline Switch—lying across the cog rack\* at an angle of 9 degrees.

This section of flip rail was 5 feet, 4¾ inches long and when set for the siding projected 2½ inches above the cog rack. The locomotive cogwheel struck the flip rail, bending it about two inches out of line; meanwhile, the engine was lifted up, to the right, and out of the cog rack and main rails. This rendered the cogwheel and brakes useless. The locomotive and coal tender

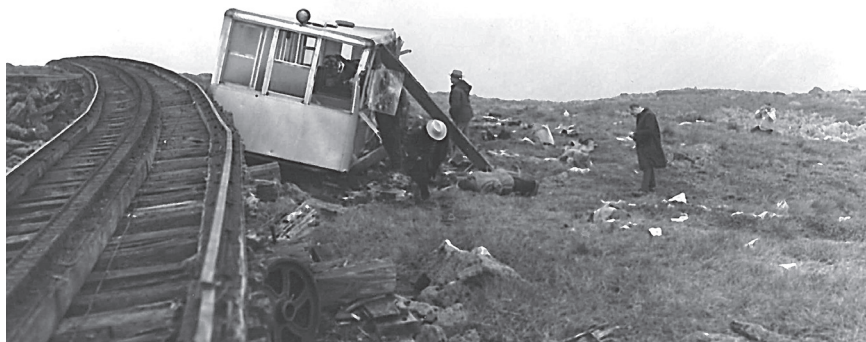
*Police investigators peer at the stilled passenger car where it landed.* NEW HAMPSHIRE STATE POLICE

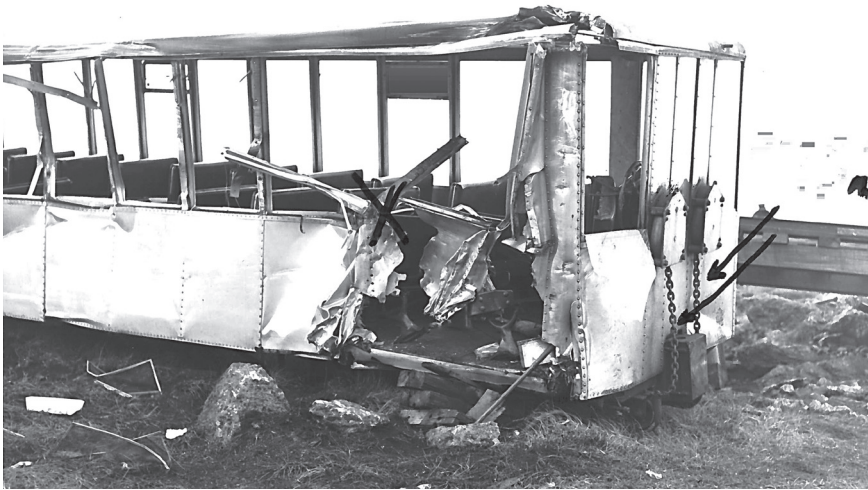
*The passenger car called Chumley 11 sits crumpled after it careened out of control and crashed into rocks high on Mount Washington. NEW HAMPSHIRE STATE POLICE*

The overfilled passenger car rolled past the overturned locomotive and gained speed until it flipped off the trestle about 516 feet from where it had derailed at Skyline Switch. Many people jumped out of the car as it tumbled. The car fell a couple of feet to the rocks below, but because of the speed and weight, it slid for about 60 feet until it hit a large jagged rock.
